*Greener Hirapur – An IRBMS Initiative*

### **Understanding Soil & Groundwater Challenges in Baropahar, Rajmahal Hills**

### **Godavari River (Part - 8) Indravati River Sub-basin**

## **The Himalayan disasters and climate change – a new reality**

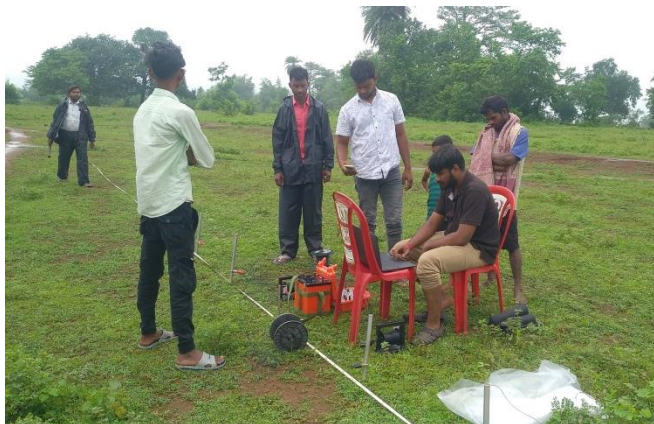
Field investigations revealed noticeable geological and hydrogeological contrasts across the hilltop. Topsoil thickness varies significantly, from about 4.5 m in the North-East to only 1 m in the South-West. The South-West ridge has shallow hard basaltic bedrock, which restricts infiltration and limits groundwater recharge.

The North-East side has thicker lateritic soil layers, offering better prospects for perched aquifers and shallow subsurface water storage. These variations directly influence groundwater recharge potential and determine what types of watershed interventions will be effective.

Based on resistivity data and terrain assessment, the study proposes site-specific watershed interventions. North-East Baropahar with Thicker lateritic cover and moderate resistivity suitable for farm ponds, percolation pits, and shallow recharge structures. The South-West Ridge having thin soil cover and massive basalt beneath and is suitable for stone bunds, recharge pits, check structures, and runoff control measures to enhance soil moisture .

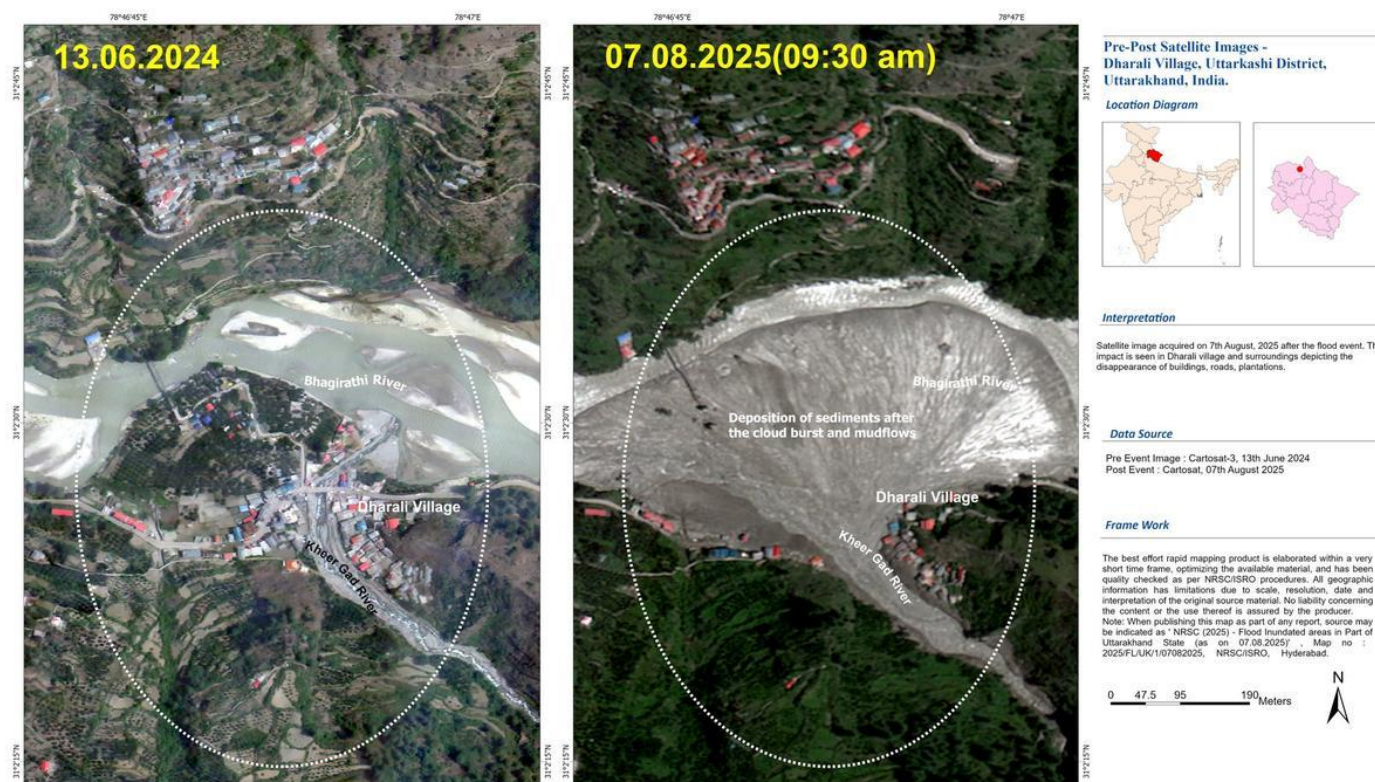
As seen in satellite image the deluge widens stream channel with redesigned river morphology leaving a fan shaped deposit of mud and debris. The deluge caused by the cloudburst, occurred in the catchment area of the Kheer Gad/ Kheer Ganga stream, forced the Bhagirathi River toward Mukhwa, disturbing the river's natural flow first striking Dharali in one side of the hill and village Sukhi Top in another side later. Dharali experienced cloudbursts before also in 1864, 2013 and 2014 leaving devastating impact along the Kheer Ganga stream.

It seemed that a part of the mountain which came off nearly six months ago and kept hanging on Kheer Ganga river dislodged this time generating colossal impact with mudslide, landslide, gigantic volume of debris, water flows leading to huge flash

floods leaving 30 feet of accumulated debris after the disaster.

with a broad mouth it widens up. When the big river shifts a little away from its earlier channel, many development work set in the new land of the abandoned part of the channel to meet the pressure of the tourism which exactly happened in Dharali. The Kheer Gad stream meets the Bhagirathi River and at the confluence it is seen from the satellite image that Bhagirathi shifts a little away from its old channel which became quickly a busy settlement area with multistoried buildings, hotels, restaurants and other activities. Interestingly, this newly developed part was totally wiped out by the gigantic force of water and the mudflow during the disaster when much of the older part of the Dharali settlement is saved.
